TR-682-001
March 1, 1993

Test Report

APU Diaphragm Testing

The Auxiliary Power Unit (APU) fuel (hydrazine) tanks were removed from the Columbia Shuttle during major modification of the vehicle, because of long-term hydrazine compatibility concerns. The three tanks had been in service for 11 years. As part of an effort to determine whether the useful life of the fuel tanks can be extended, examination of the ethylene propylene rubber (EPR) diaphragm and the metal casing from one of the APU tanks was required. NASA Johnson Space Center Propulsion and Power Division requested the NASA Johnson Space Center White Sands Test Facility to examine the EPR diaphragm for signs of degradation that might limit the life of its function in the APU tank and to examine the metal casing for signs of surface corrosion. No appreciable degradation of the EPR diaphragm was noted. A decrease in the tensile properties was found, but tensile failure is considered unlikely because the metal casing constrains the diaphragm, preventing it from elongating more than a few percent. The titanium casing showed no evidence of surface corrosion.

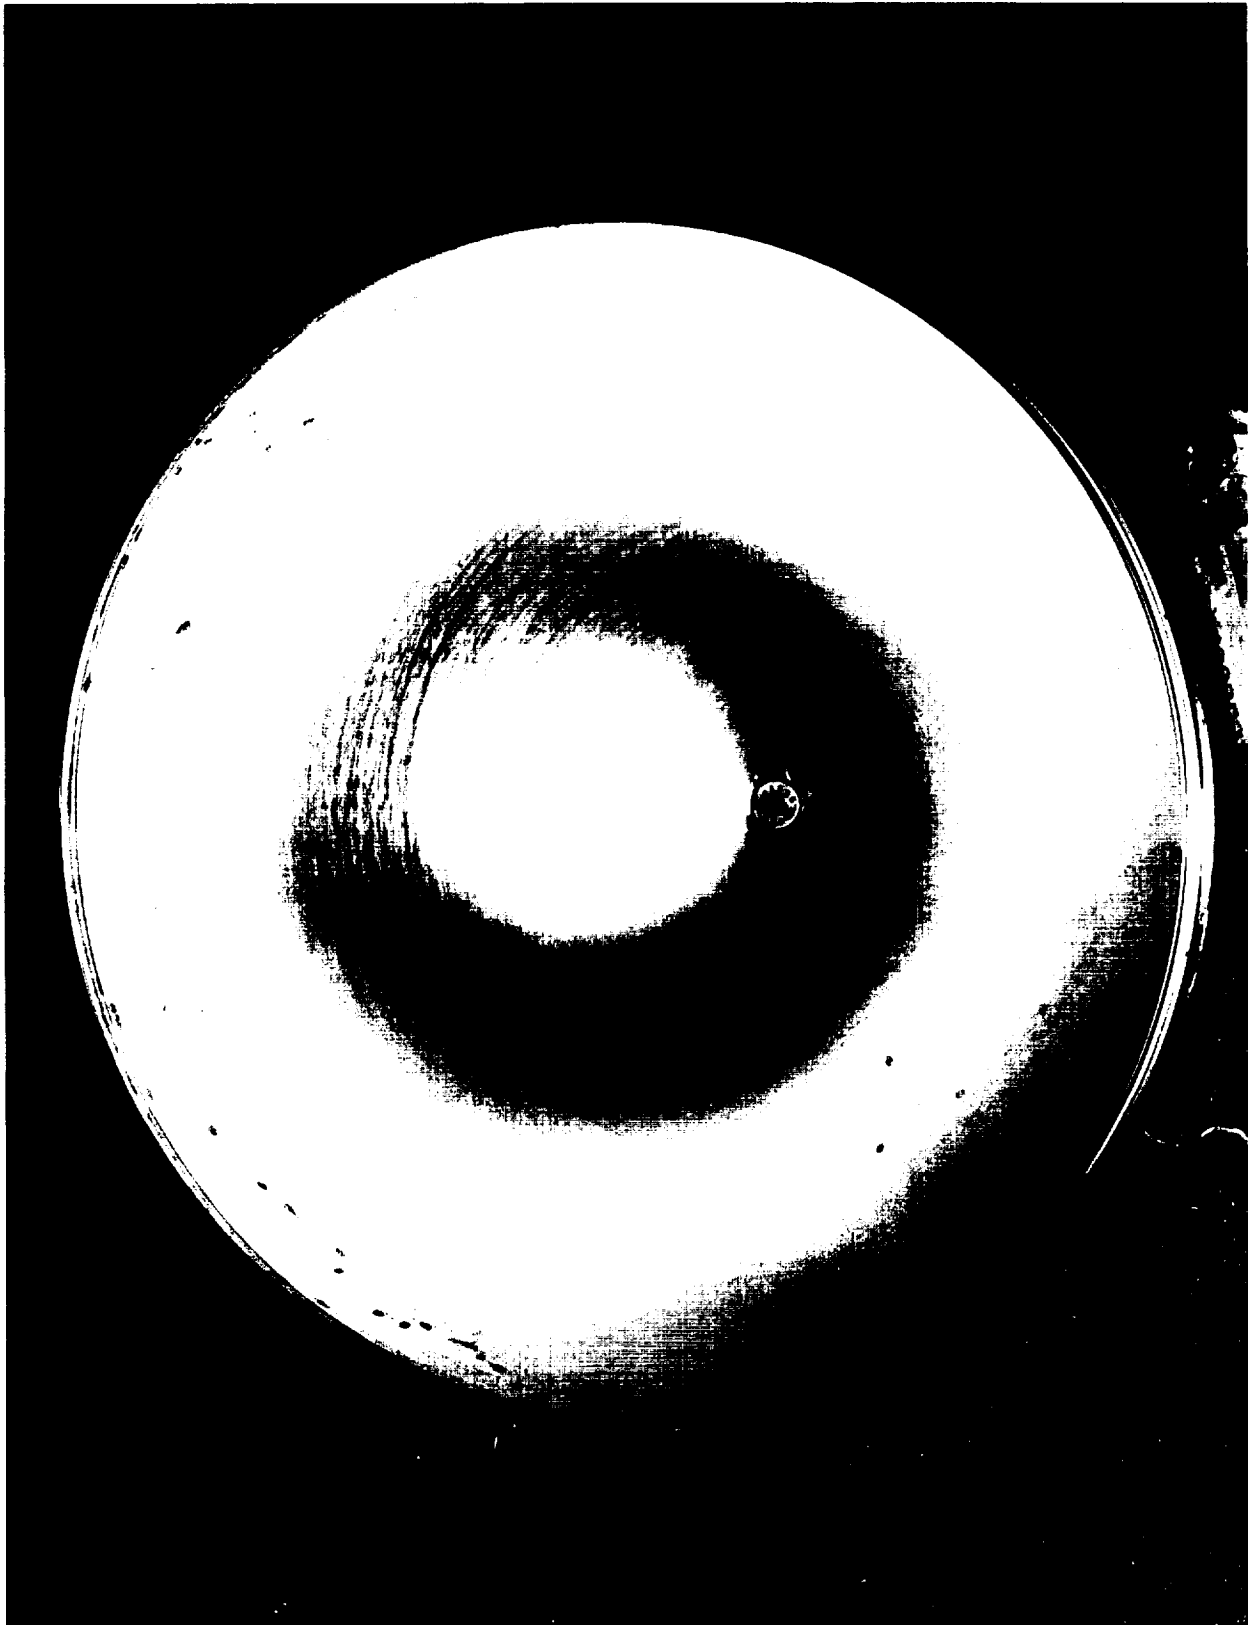
Figure H-20
Interior View of Metal Casing Gas Side
